2nd Brigade Barracks Complex – Phase 1 and 2

**Volume V of VI – Asbestos Surveys and
Hazardous Building Materials Surveys**

Asbestos Survey

**Building No. 5430 Fort Bragg, North
Carolina**

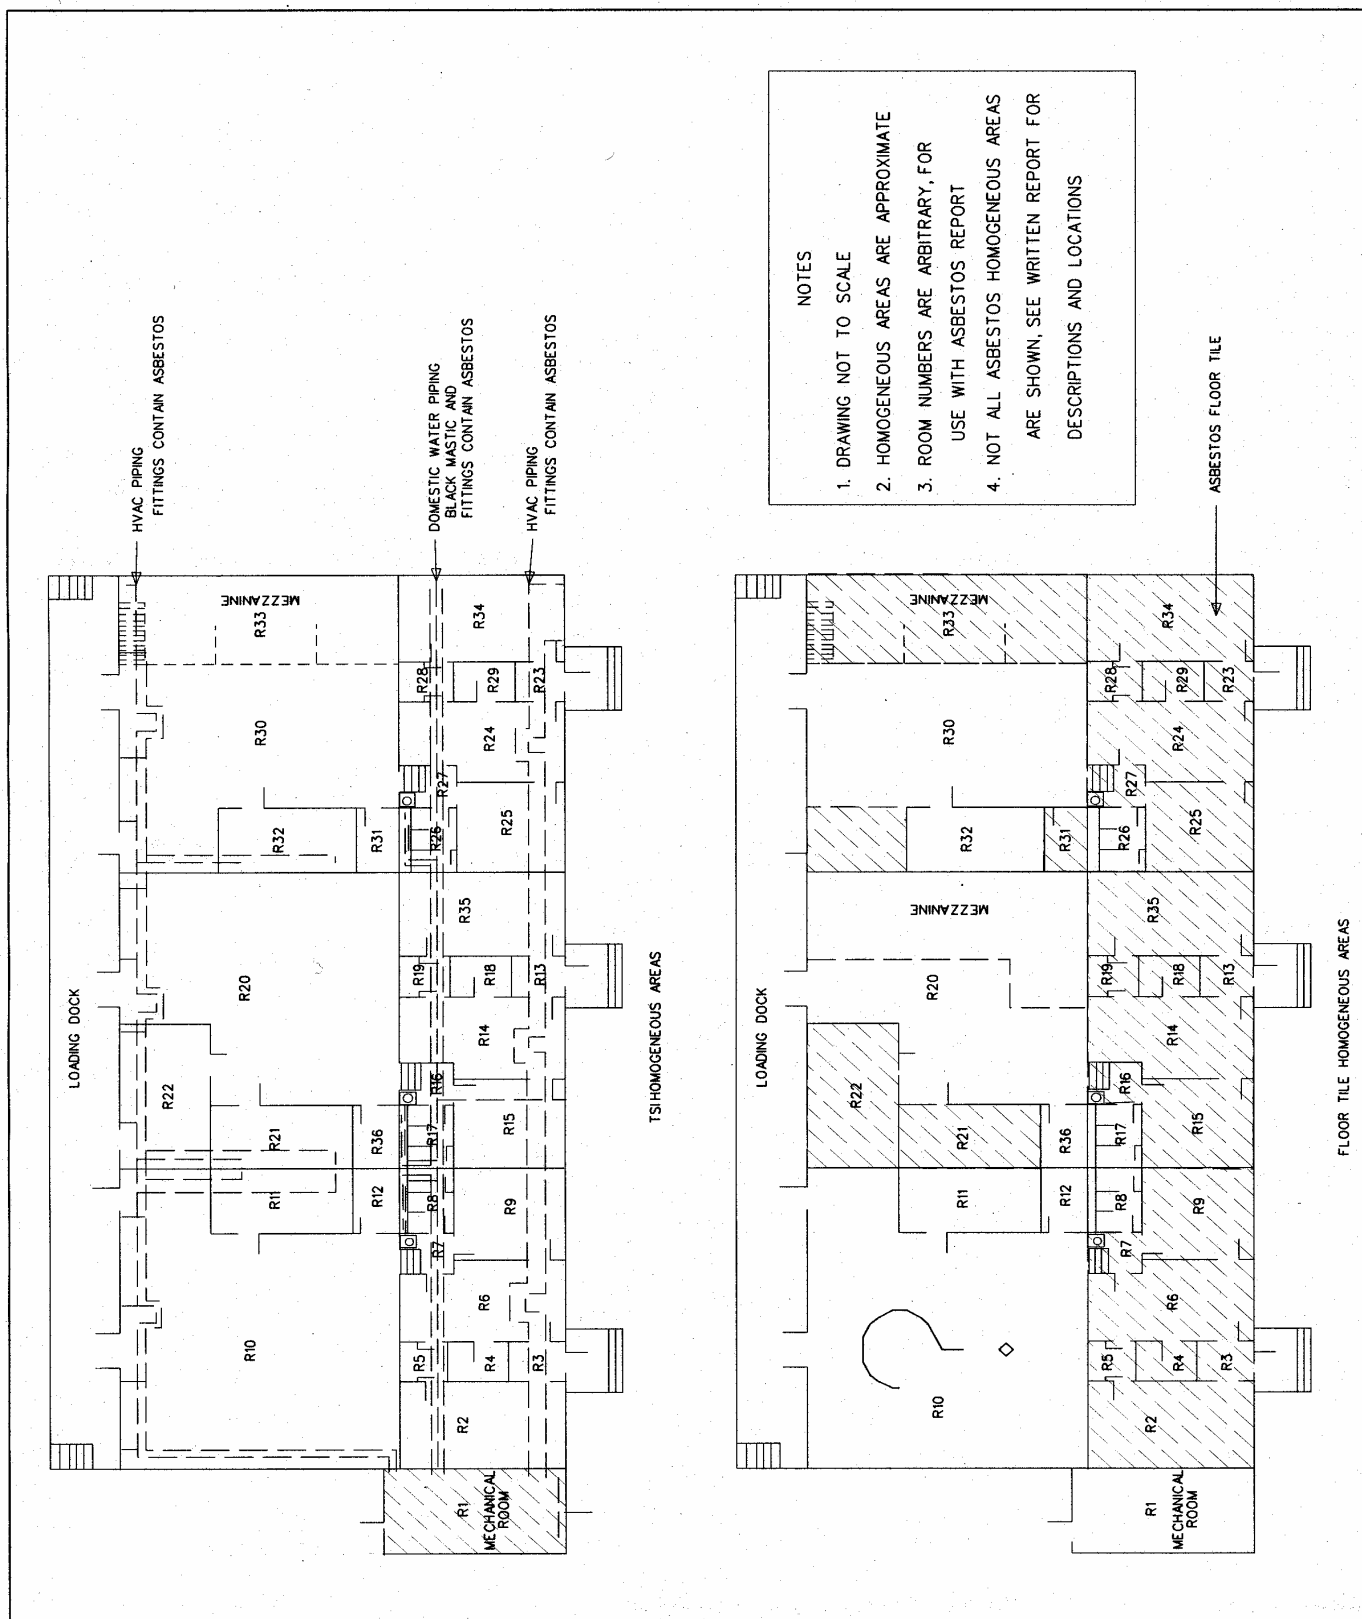
- a. Flooring Materials:* All vinyl floor tiles and associated mastic in the office areas and small sections of the storage areas are assumed to contain asbestos. - (Refer to Tables 2 and 3 for specific information, and Figure 2 for homogeneous area locations).
- b. Window Glazing Compound:* Window glazing compound on the interior of the windows contains asbestos. This material is normally installed in 1" wide strips along all sides of the glass windowpanes. - (Refer to Tables 1, 2 and 3 for specific information and Figure 1 for sample locations).
- c. Mastics:* The adhesive mastic used to attach the metal stickpins to the underside of the steel roof deck over the office areas contains asbestos. These stickpins are used to mount the fiberglass batting insulation to the roof deck and are approximately 2" square. They are located approximately 1 foot apart on the
